Transport
Canada

TP 185E
Issue 3/2009

AVIATION SAFETY LETTER

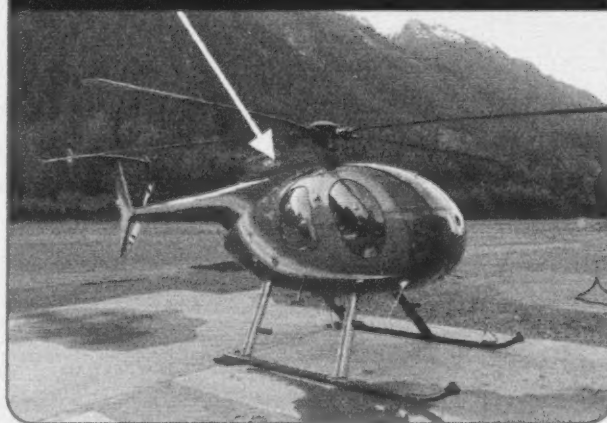
The cover did not have any straps or physical barriers that fall at or below human eye level. Once the pilot gets into the helicopter, there are no visual clues of the cover's installation. Before this occurrence, it was expected that the engine would not start with the cover installed, but we now know that as soon as the rotor started turning, the cover opened enough to let in sufficient air for the start.

Photo 1: Doghouse cover

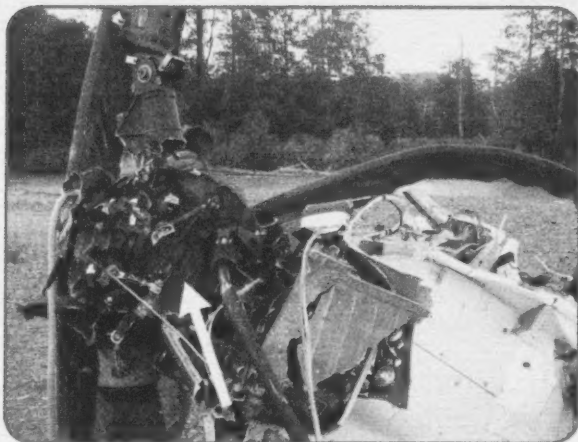
Photo 2: Doghouse cover wrapped between controls

It is clear that the removal of the cover was missed during flight preparation and that the cover damaged the main rotor controls while the rotor was turning. Also, rotor rpm was likely lost due to the binding effect that the cover had as it squeezed between the stationary and rotating components of the swashplate assembly. This rendered the helicopter uncontrollable after the takeoff, and it collided with terrain.

1. The doghouse cover was not removed before flight and it wrapped around the flight controls linkage, damaged the linkage, and rendered the helicopter uncontrollable.
2. The helicopter fell in an uncontrolled state, with reduced rotor rpm, until it collided with terrain.
3. Anomalies in the pilot's routine and the lack of physical barriers likely caused him to miss removing the cover before the flight.

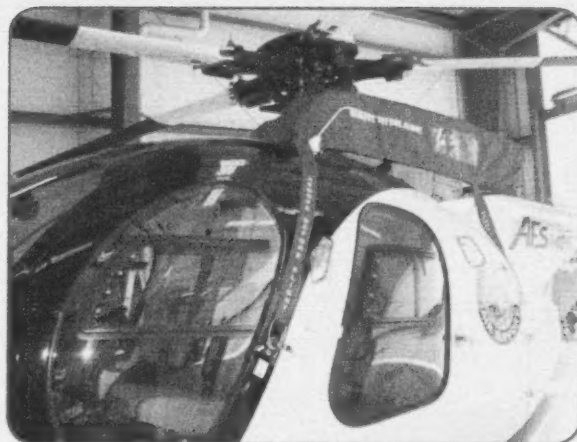
Photo 3: Modified doghouse cover

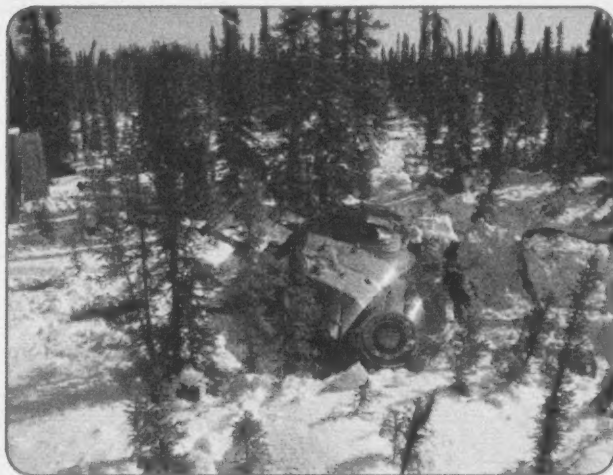
TSB Final Report A06W0041—Airframe Failure and Collision with Terrain

1. The attach fitting at the upper right attachment point of the tail boom failed in fatigue. The transfer of loads to the adjacent aft ring structure resulted in the cascading failure of the remaining three tail boom attach fittings and separation of the tail boom from the fuselage.
2. Aircraft control was lost following separation of the tail boom. Safe recovery following this type of structural failure was unlikely.

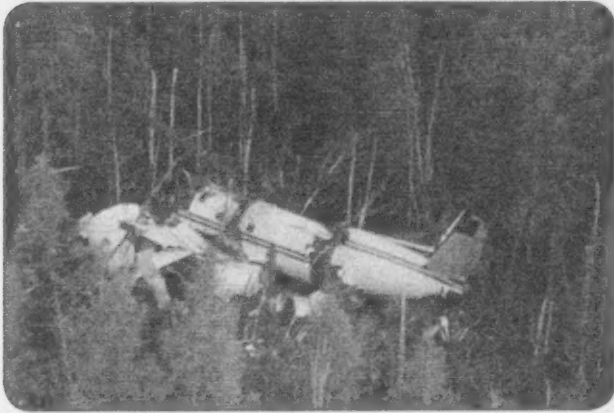
1. The flight crew attempted a low-energy go-around after briefly touching down on the runway. The aircraft's low-energy state contributed to its inability to accelerate to the airspeed required to accomplish a successful go-around procedure.

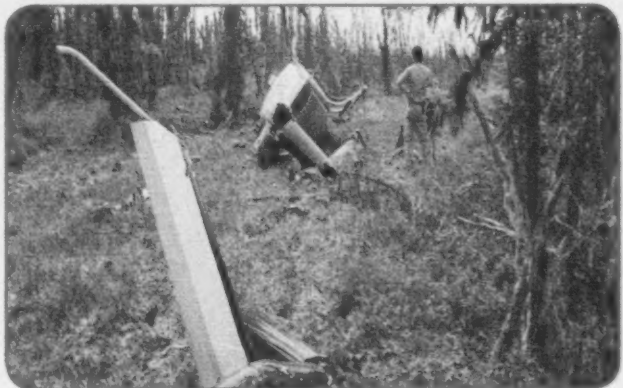
TSB Final Report A06W0106—Dynamic Rollover

1. The pilot undertook a water-bucketing mission for which he did not have the required training and experience.
2. The pilot engaged in flight operations with pronounced allergy symptoms, which probably contributed to reducing his ability to perform complex multi-task missions.
3. It is probable that the pilot took a quantity of an allergy medication that could have affected his ability to stay alert and be aware of all surrounding mission factors.
4. The operator had no system in place to ensure that flight crews did not undertake missions or use equipment for which they were not trained.

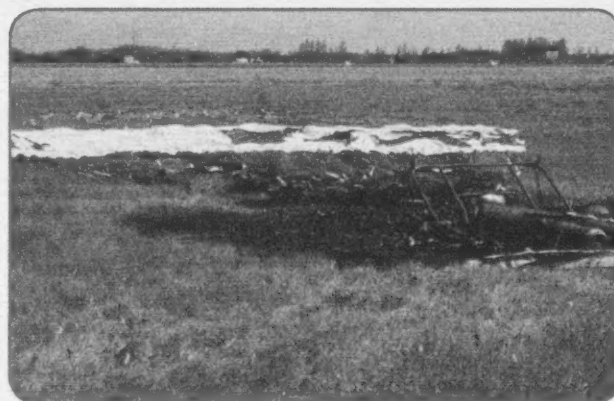
1. The flight continued even though the winds exceeded the maximum demonstrated winds listed in the balloon flight manual, and were at the upper wind limit specified in the company operations manual.

2. The fuel system was not shut down as recommended in the balloon flight manual procedures for a hard landing, even though a hard landing was likely.
3. Because the balloon was not deflated quickly, the basket was dragged for some 700 ft and the integrity of the burner support structure was lost.
4. As the basket was dragged across the ground, the fuel-line fittings were pulled out at the burner manifolds and liquid propane was released in the vicinity of the pilot lights, resulting in the fire and subsequent explosion.

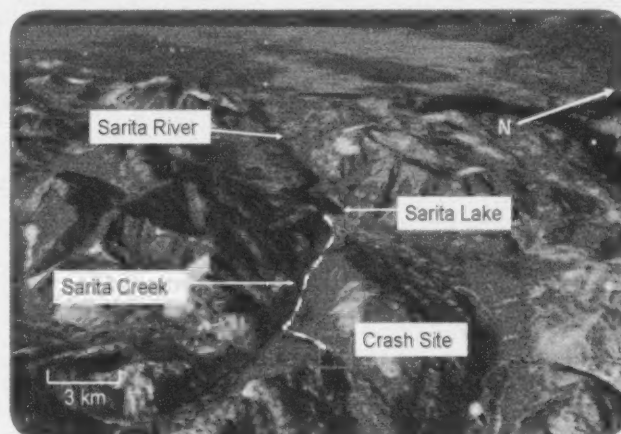
Figure 1: Likely track of aircraft from Sarita Lake

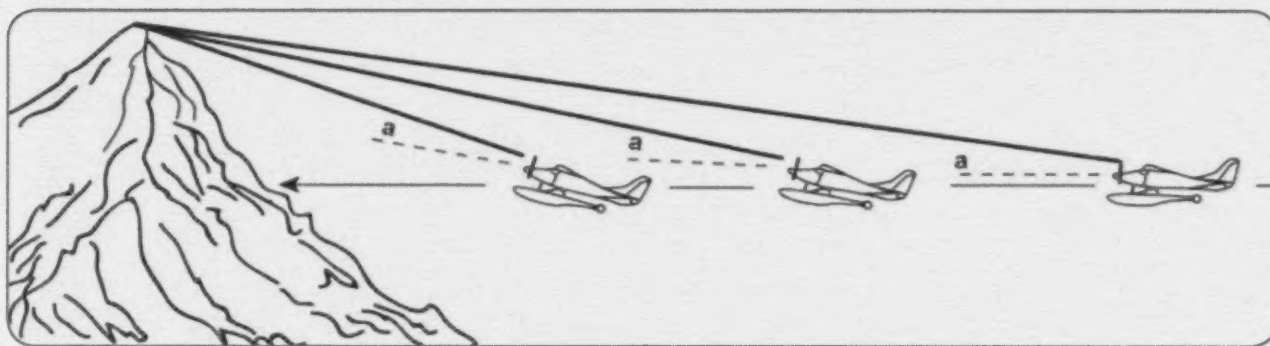
Figure 2: Aircraft performance and terrain profile (angles exaggerated for clarity)

can result in a gradual increase in aircraft pitch attitude and a concurrent decrease in the aircraft's airspeed as the aircraft approaches the elevated terrain (see Figure 2). This often results in a delay to the pilot's realization of inadequate aircraft climb performance ("a" in Figure 2), the aircraft's separation with the terrain decreases and the aircraft gets closer to aerodynamic stall as the angle of attack increases.
